FUEL CONTAINMENT AND DAMAGE TOLERANCE IN LARGE COMPOSITE PRIMARY AIRCRAFT STRUCTURES PHASE II -- TESTING

NASA Contract No. NAS 1-16856

April, 1985

NASA CONTRACTOR REPORT 172519

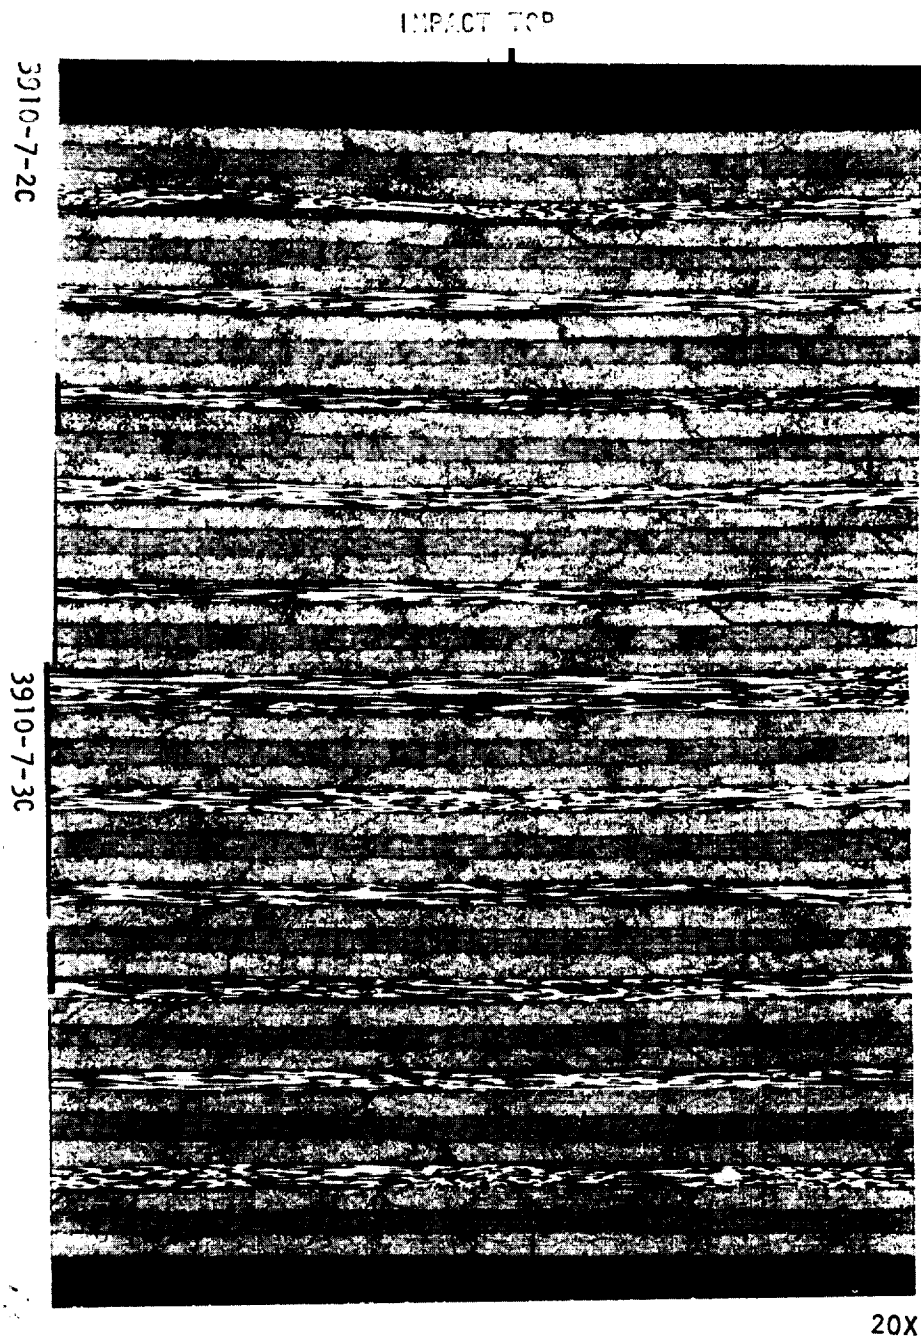
Panel 210-iB
20 ft-lbs

Figure 2-19: Center of impact area of high strain Celion/HX1504 at 20 ft-lbs. The arrow indicates the impact location. Note matrix cracking and delamination.

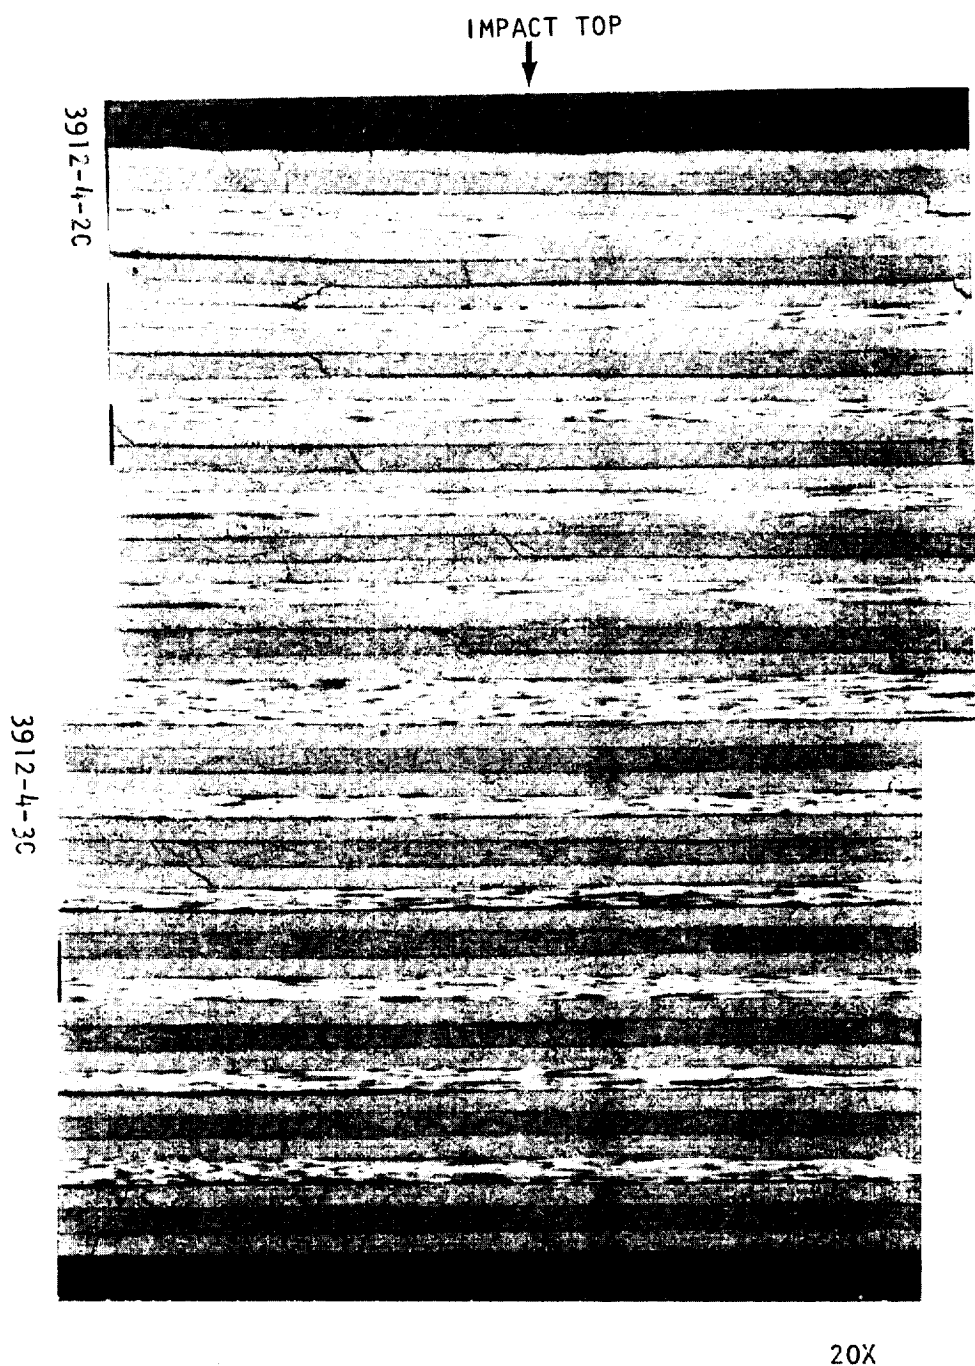
Panel 243-1B
20 ft-lbs

Figure 2-21: Center of impact area of high strain Celion/5245 at 20 ft-lbs. The arrow indicates the impact location. Note matrix cracking and delamination.

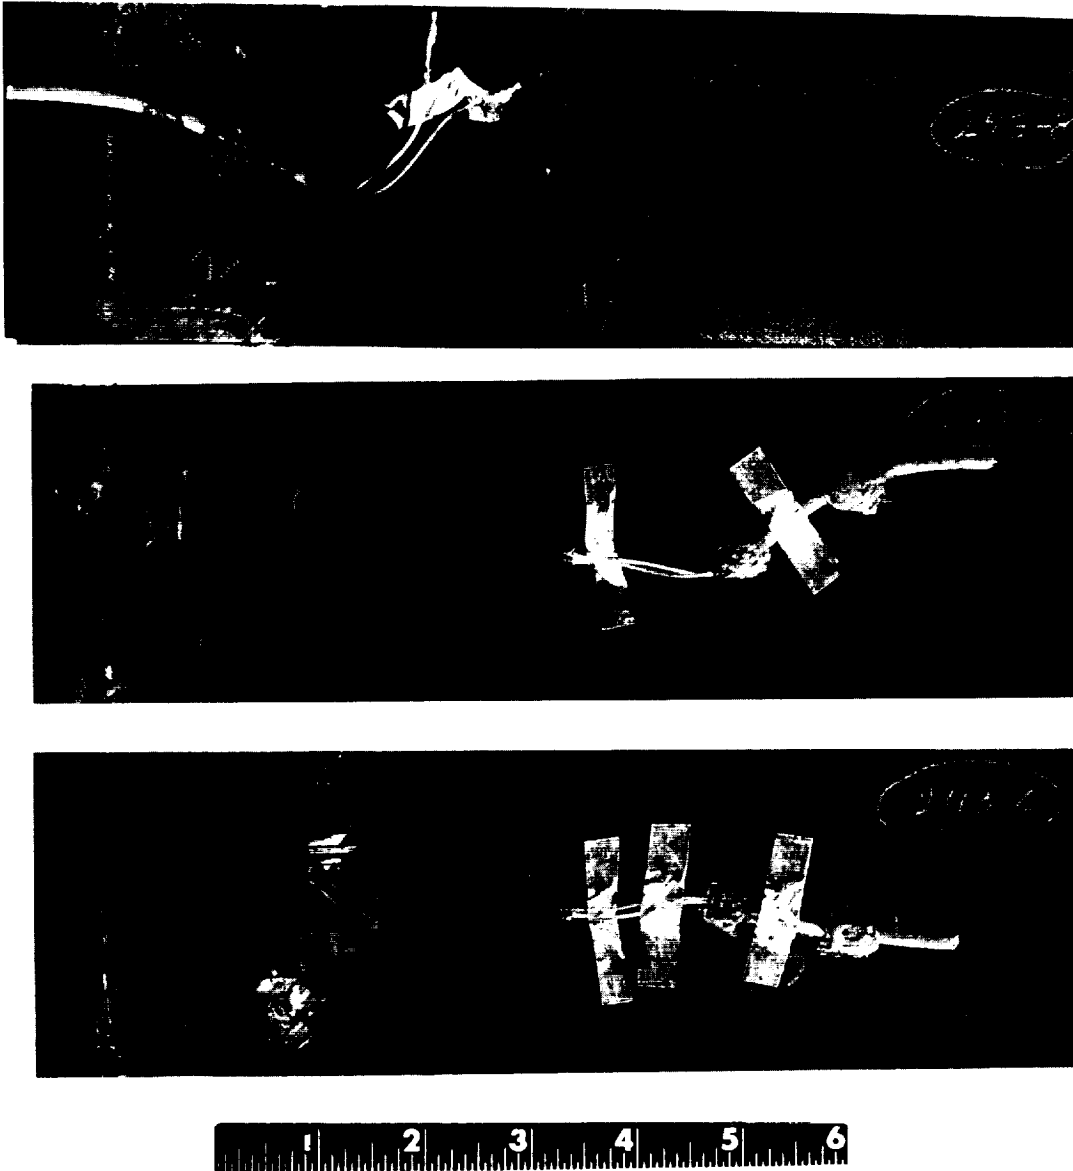
Figure 2-27a: Typical failures of unnotched compression specimens tested at room temperature: front view.

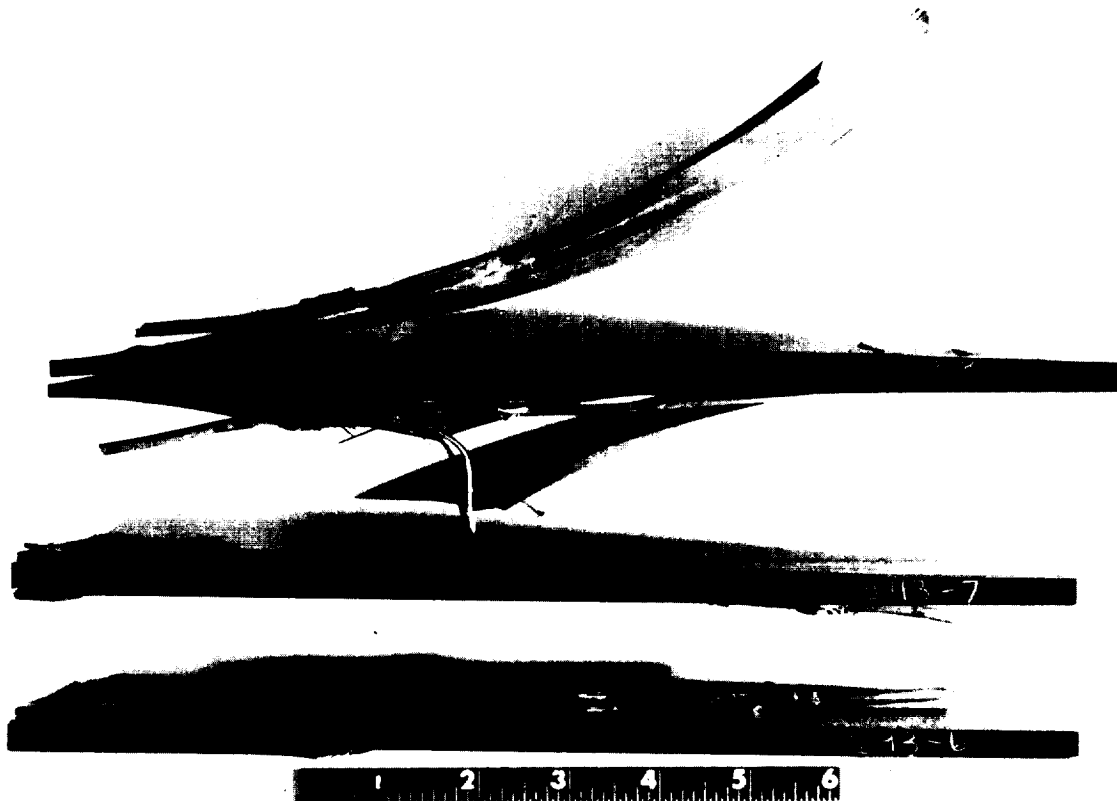
Figure 2-27b: Typical failures of unnotched compression specimens tested at room temperature: edge view.

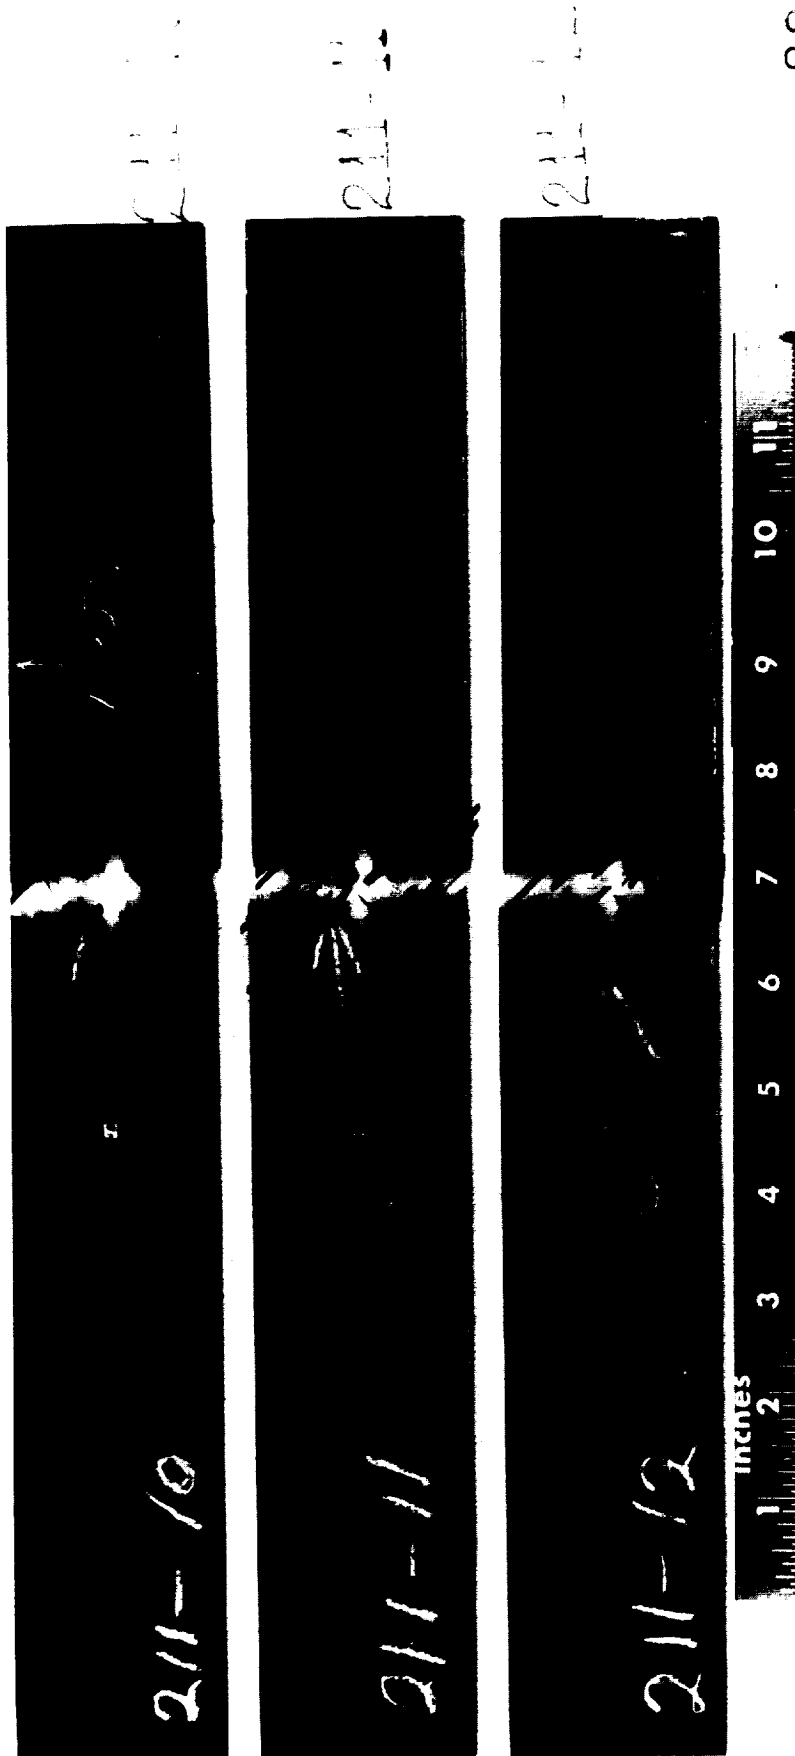
Figure 2-34: Typical failure of notched tension tests.

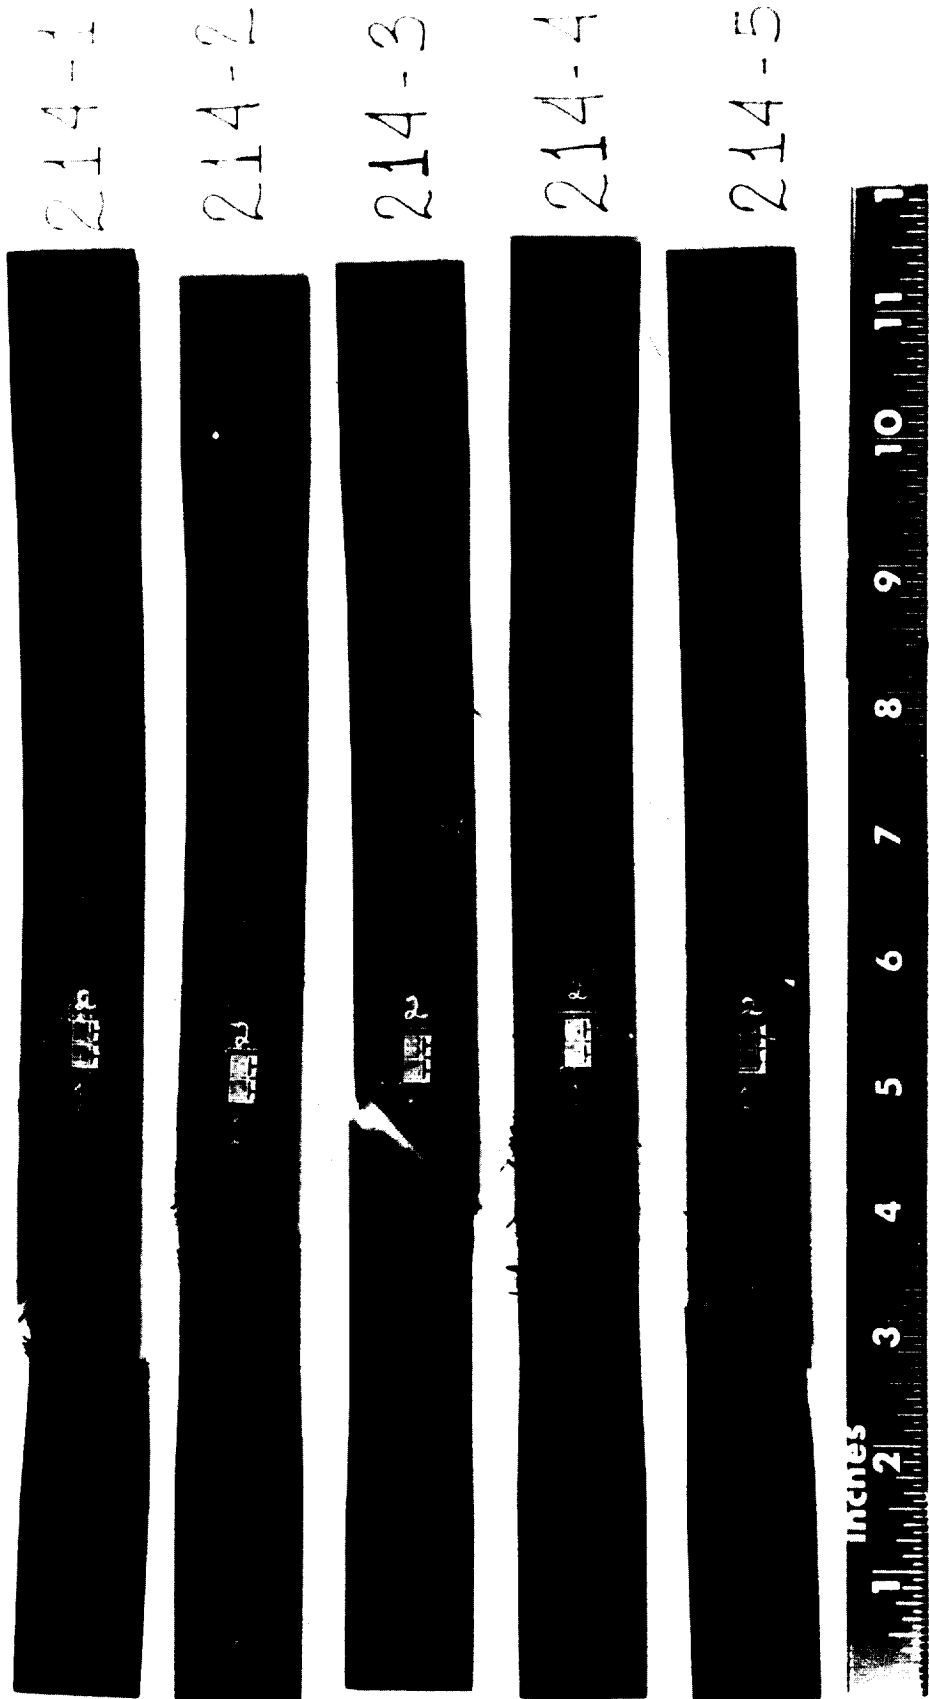
Figure 2-40: Typical $+45^\circ$ tension test failures.

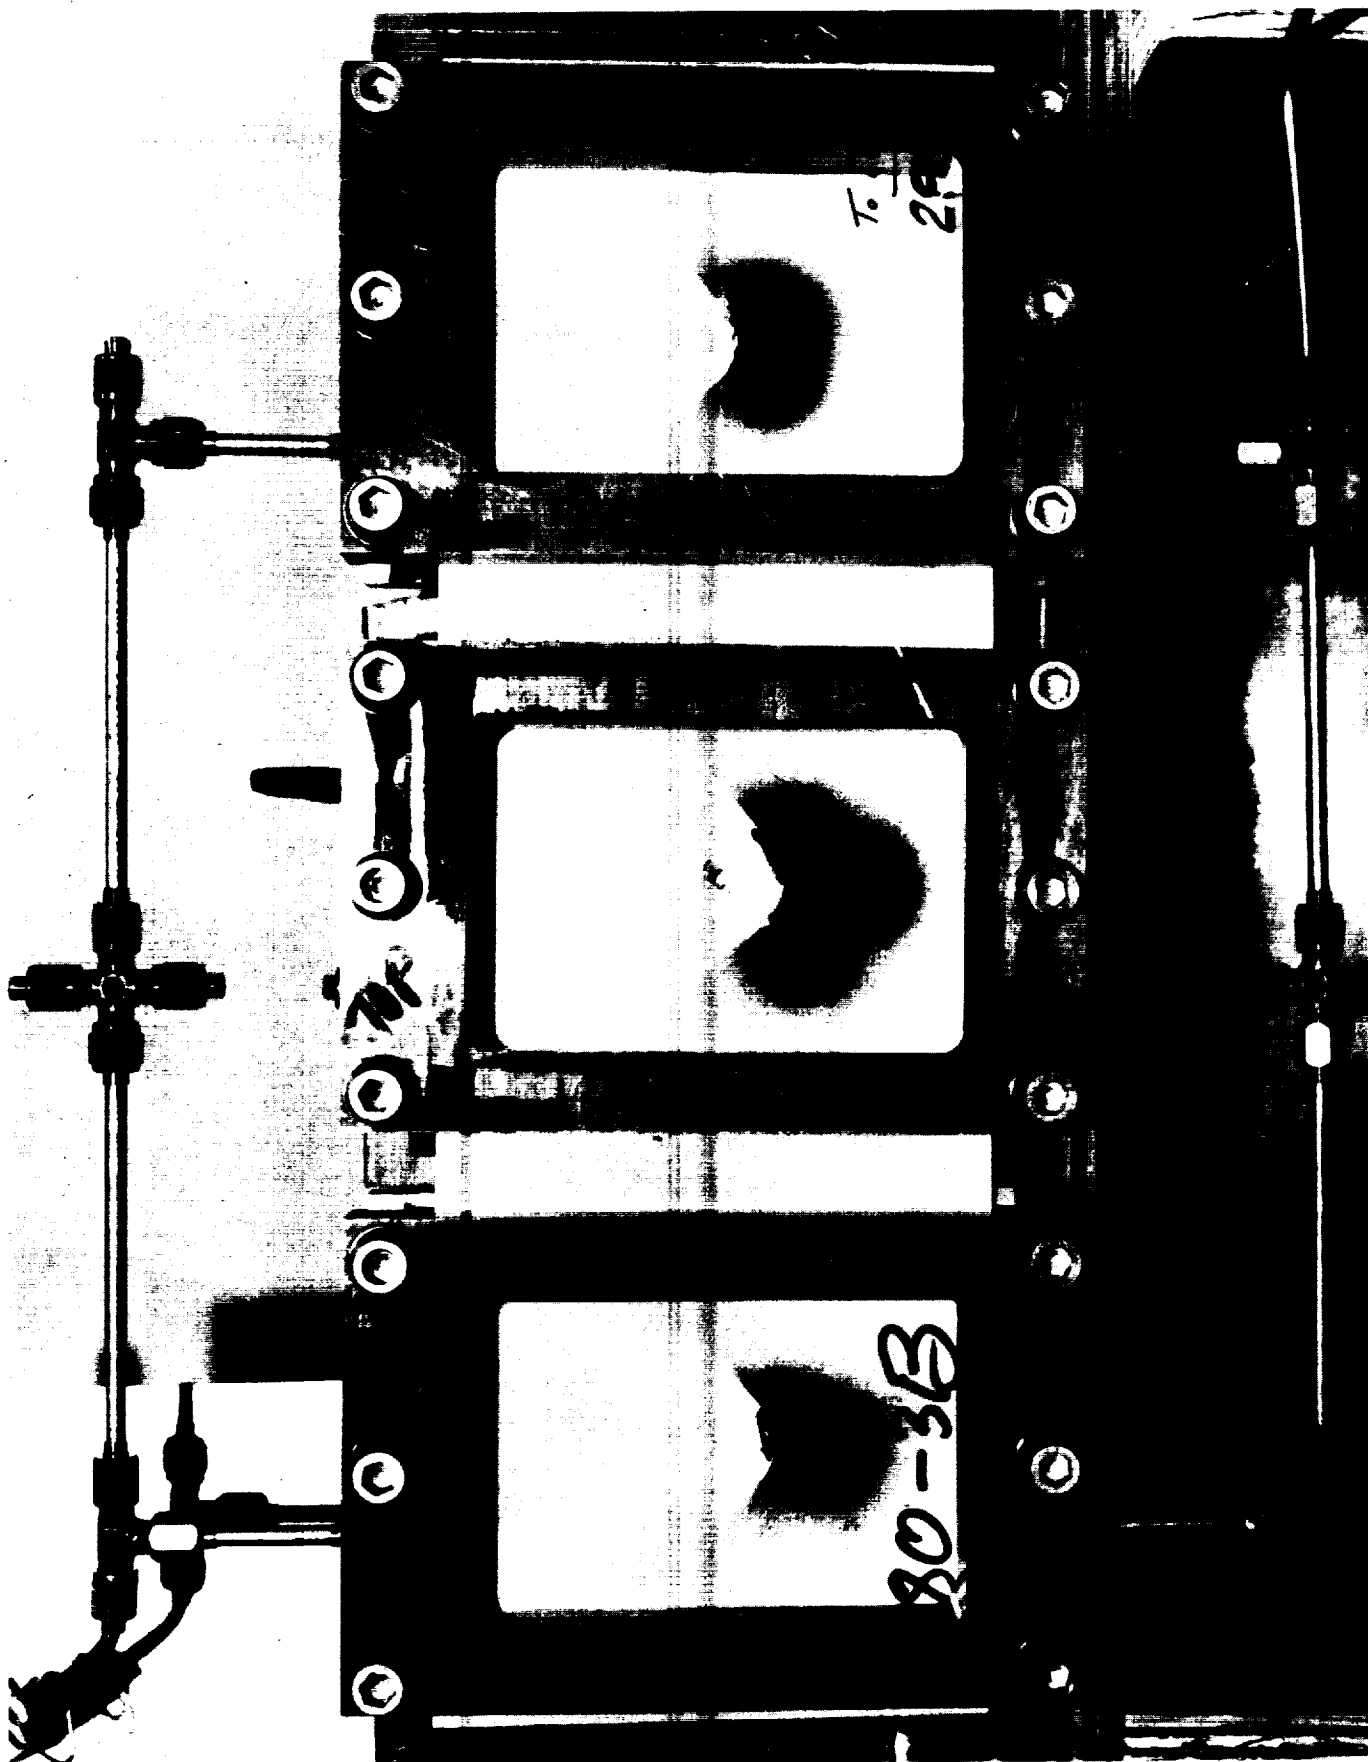
Figure 3-4: A close up of the test showing where fuel has leaked and flowed over the black paint.
The center impact was 30 ft-lbs.

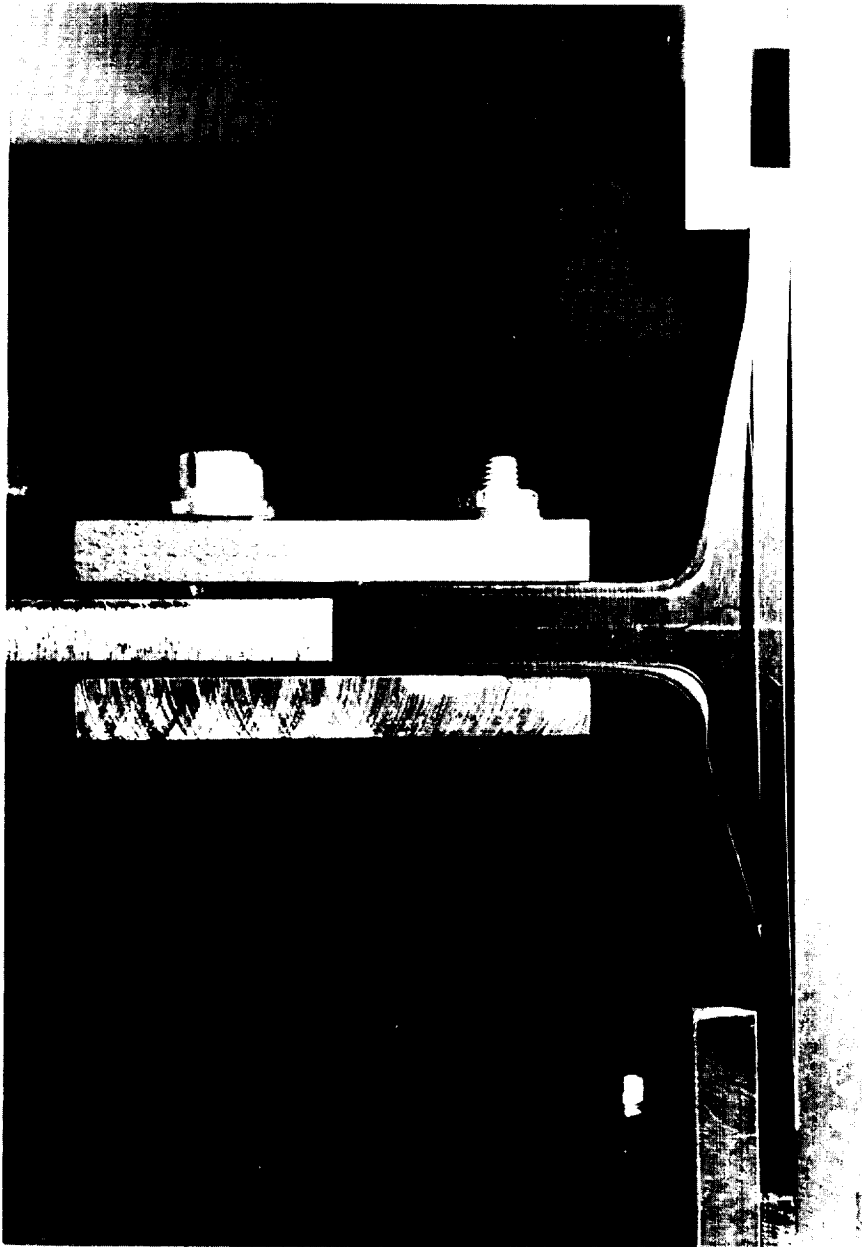
Figure 4-8: Typical failure of stiffener pull-off specimen (C3). First cracks were in the blade, second around the radius, and lastly horizontal delamination.

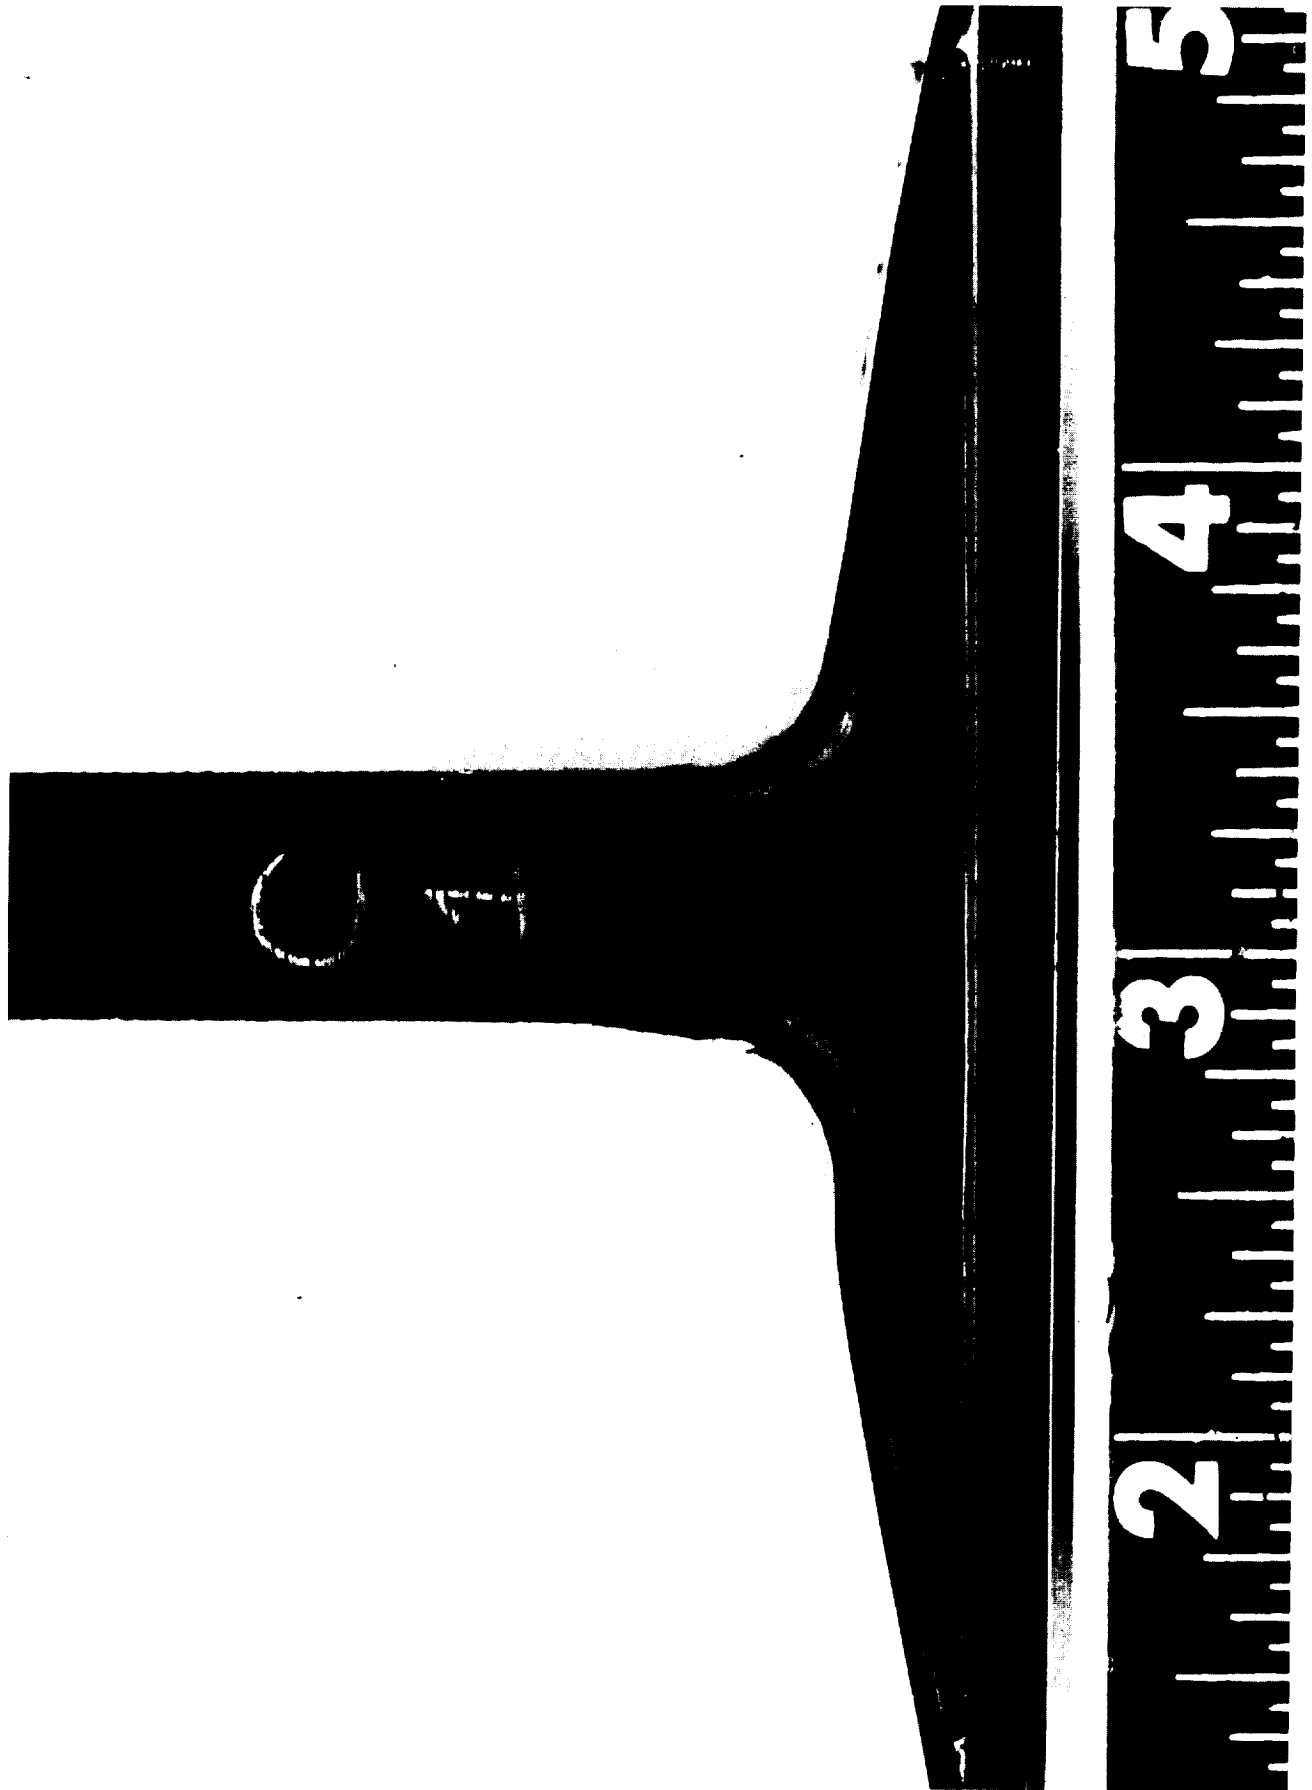
Figure 4-13: Stiffener pull-off specimen C1 failure.

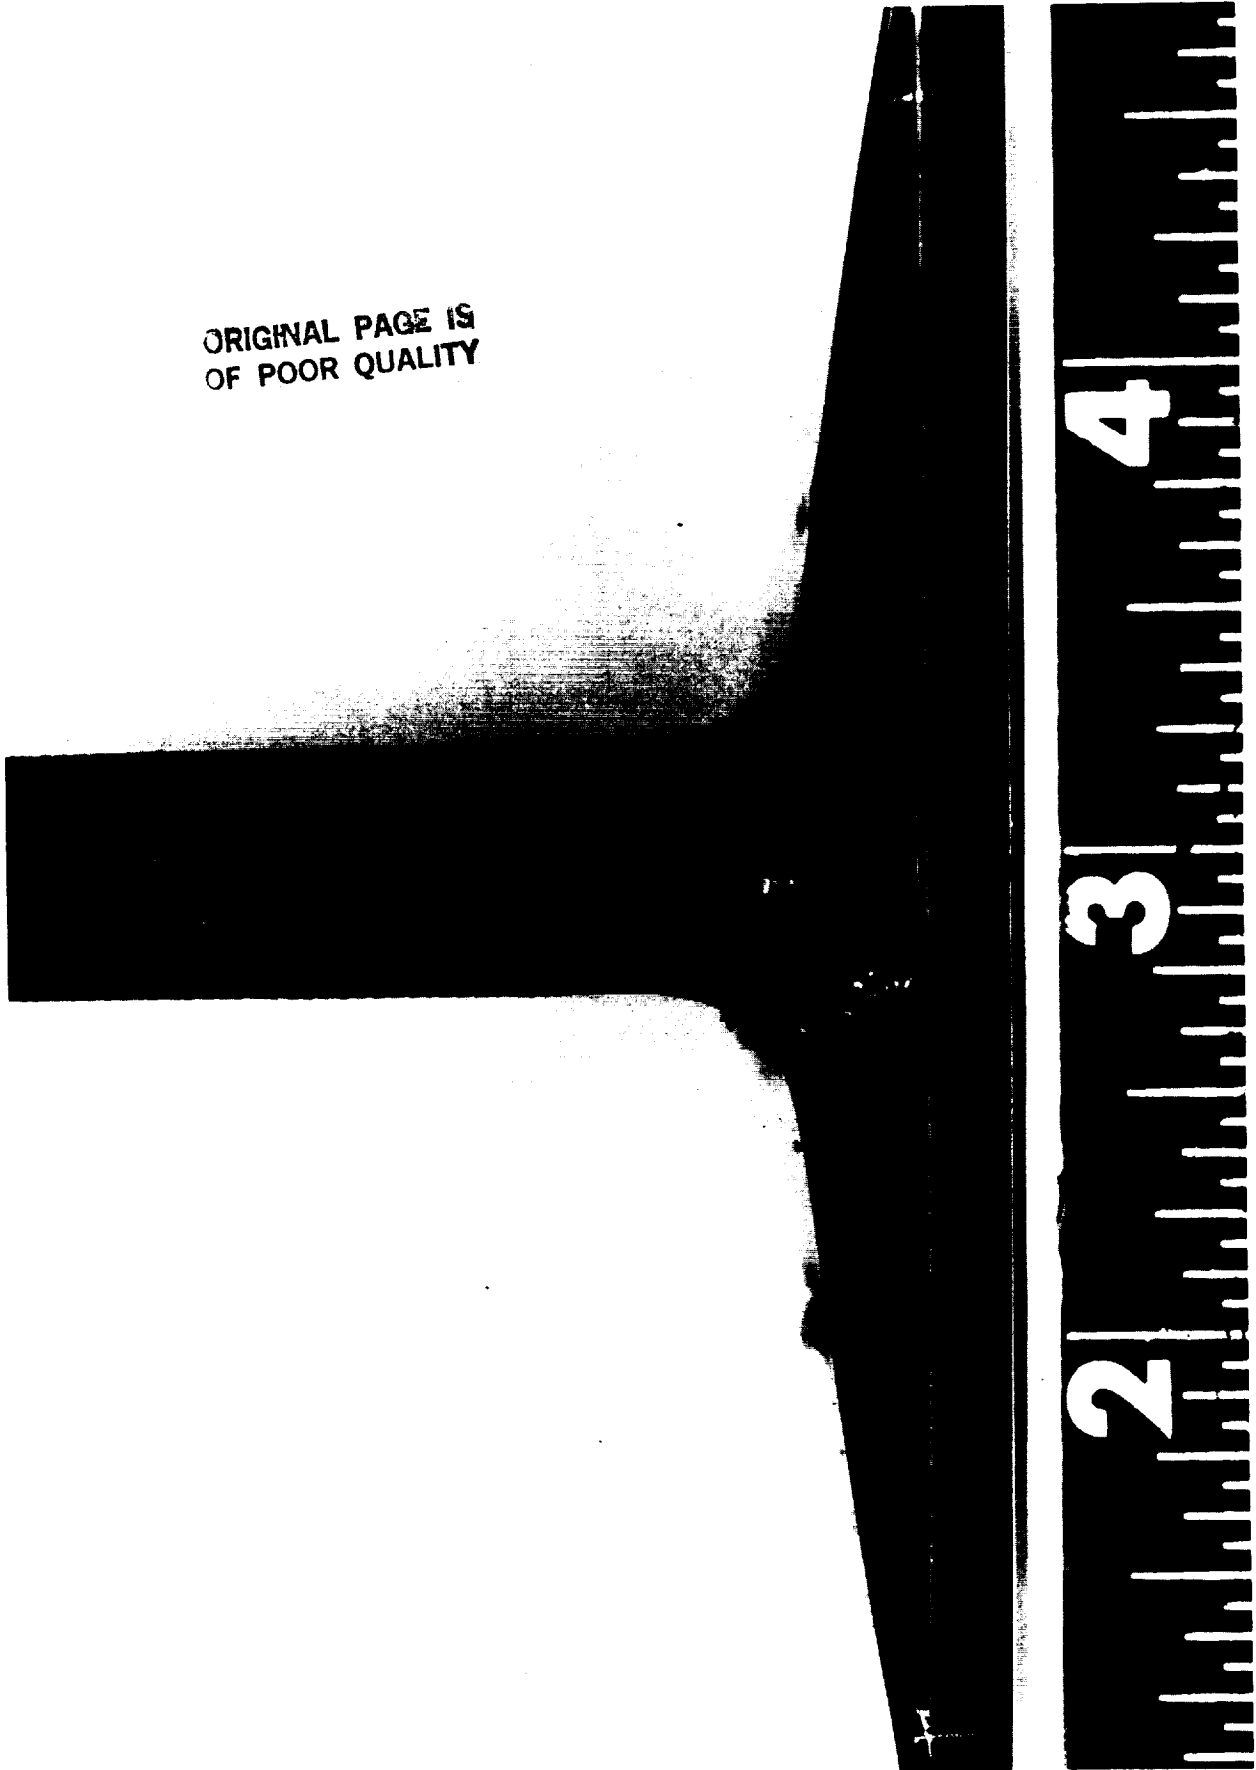
Figure 4-14: Stiffener pull-off specimen C2 failure.

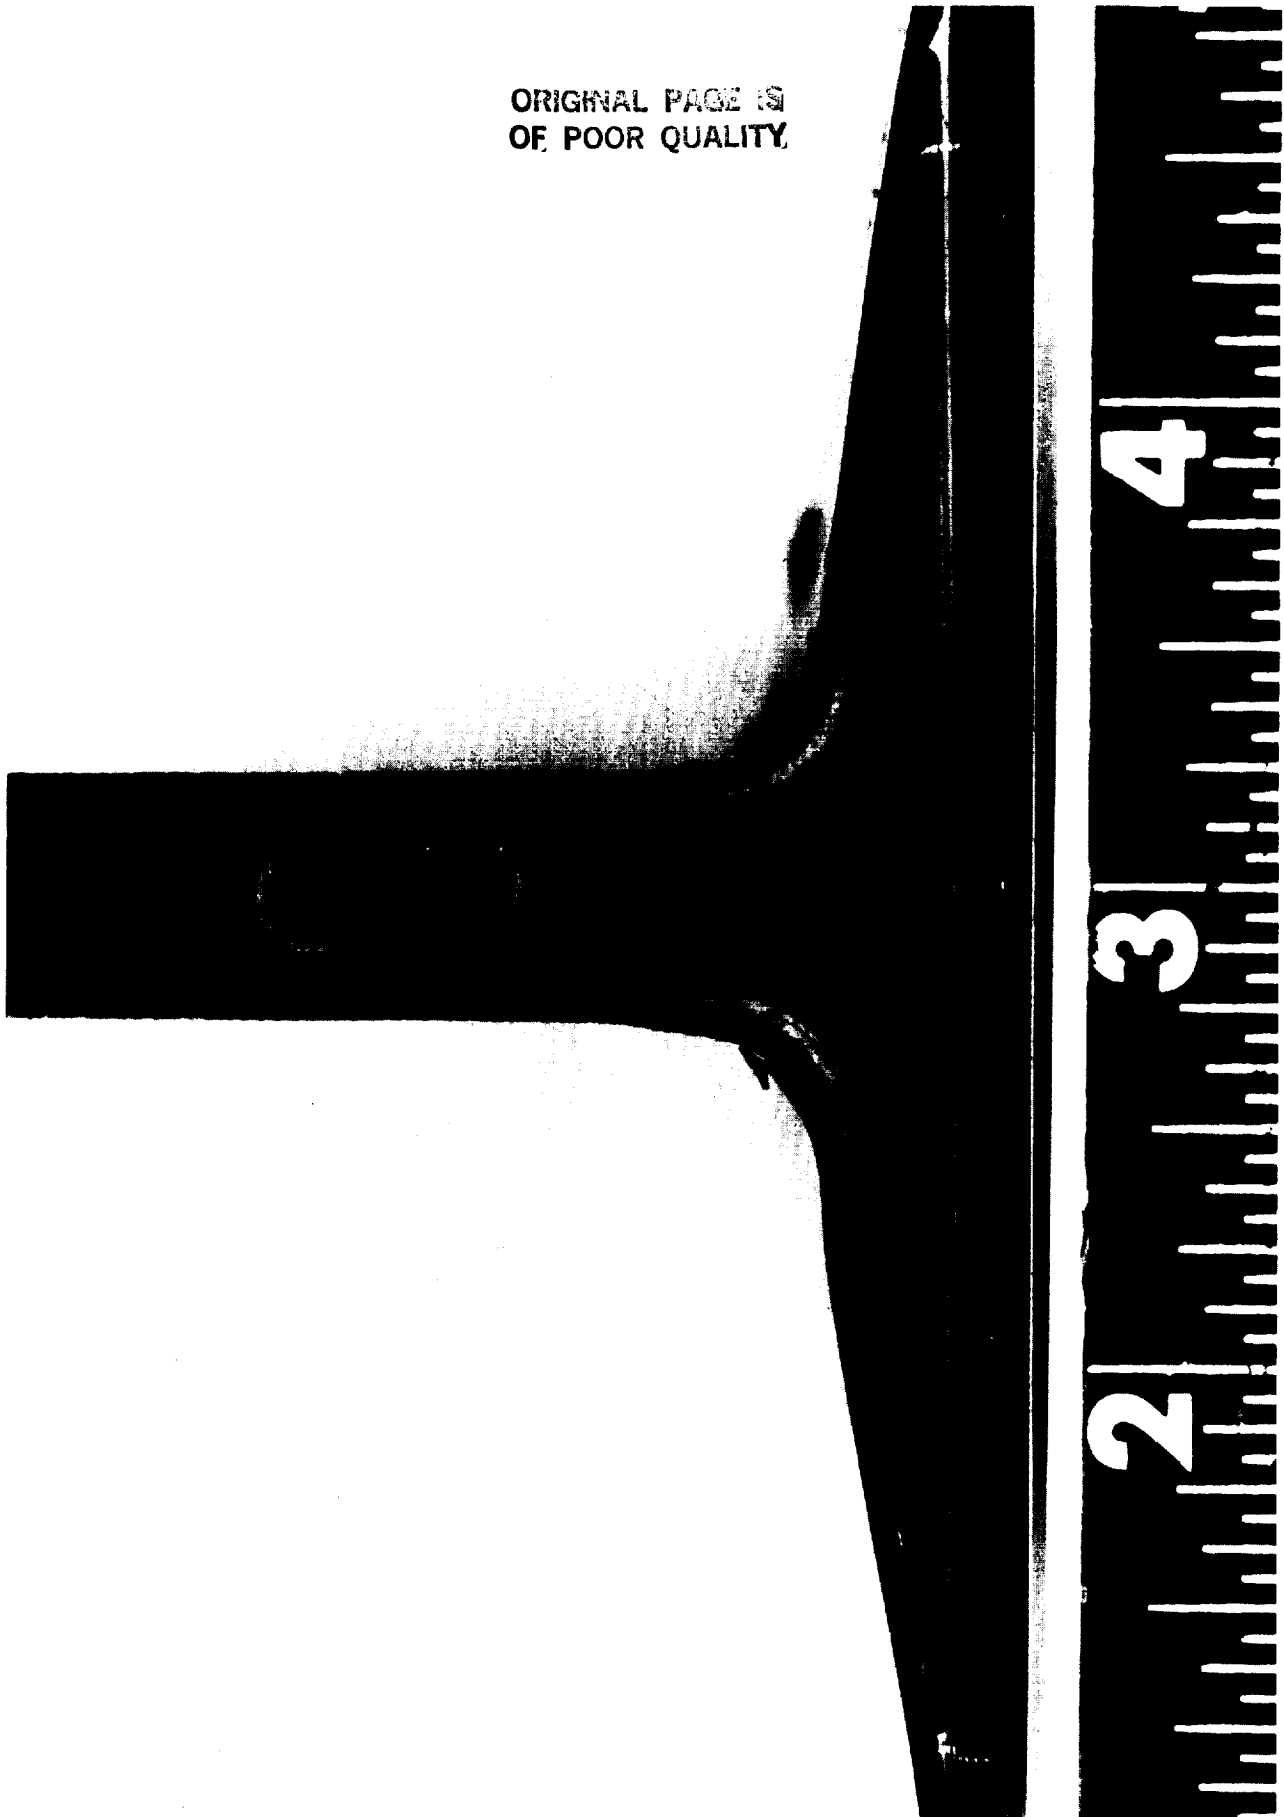
Figure 4-15: Stiffener pull-off specimen C3 failure.

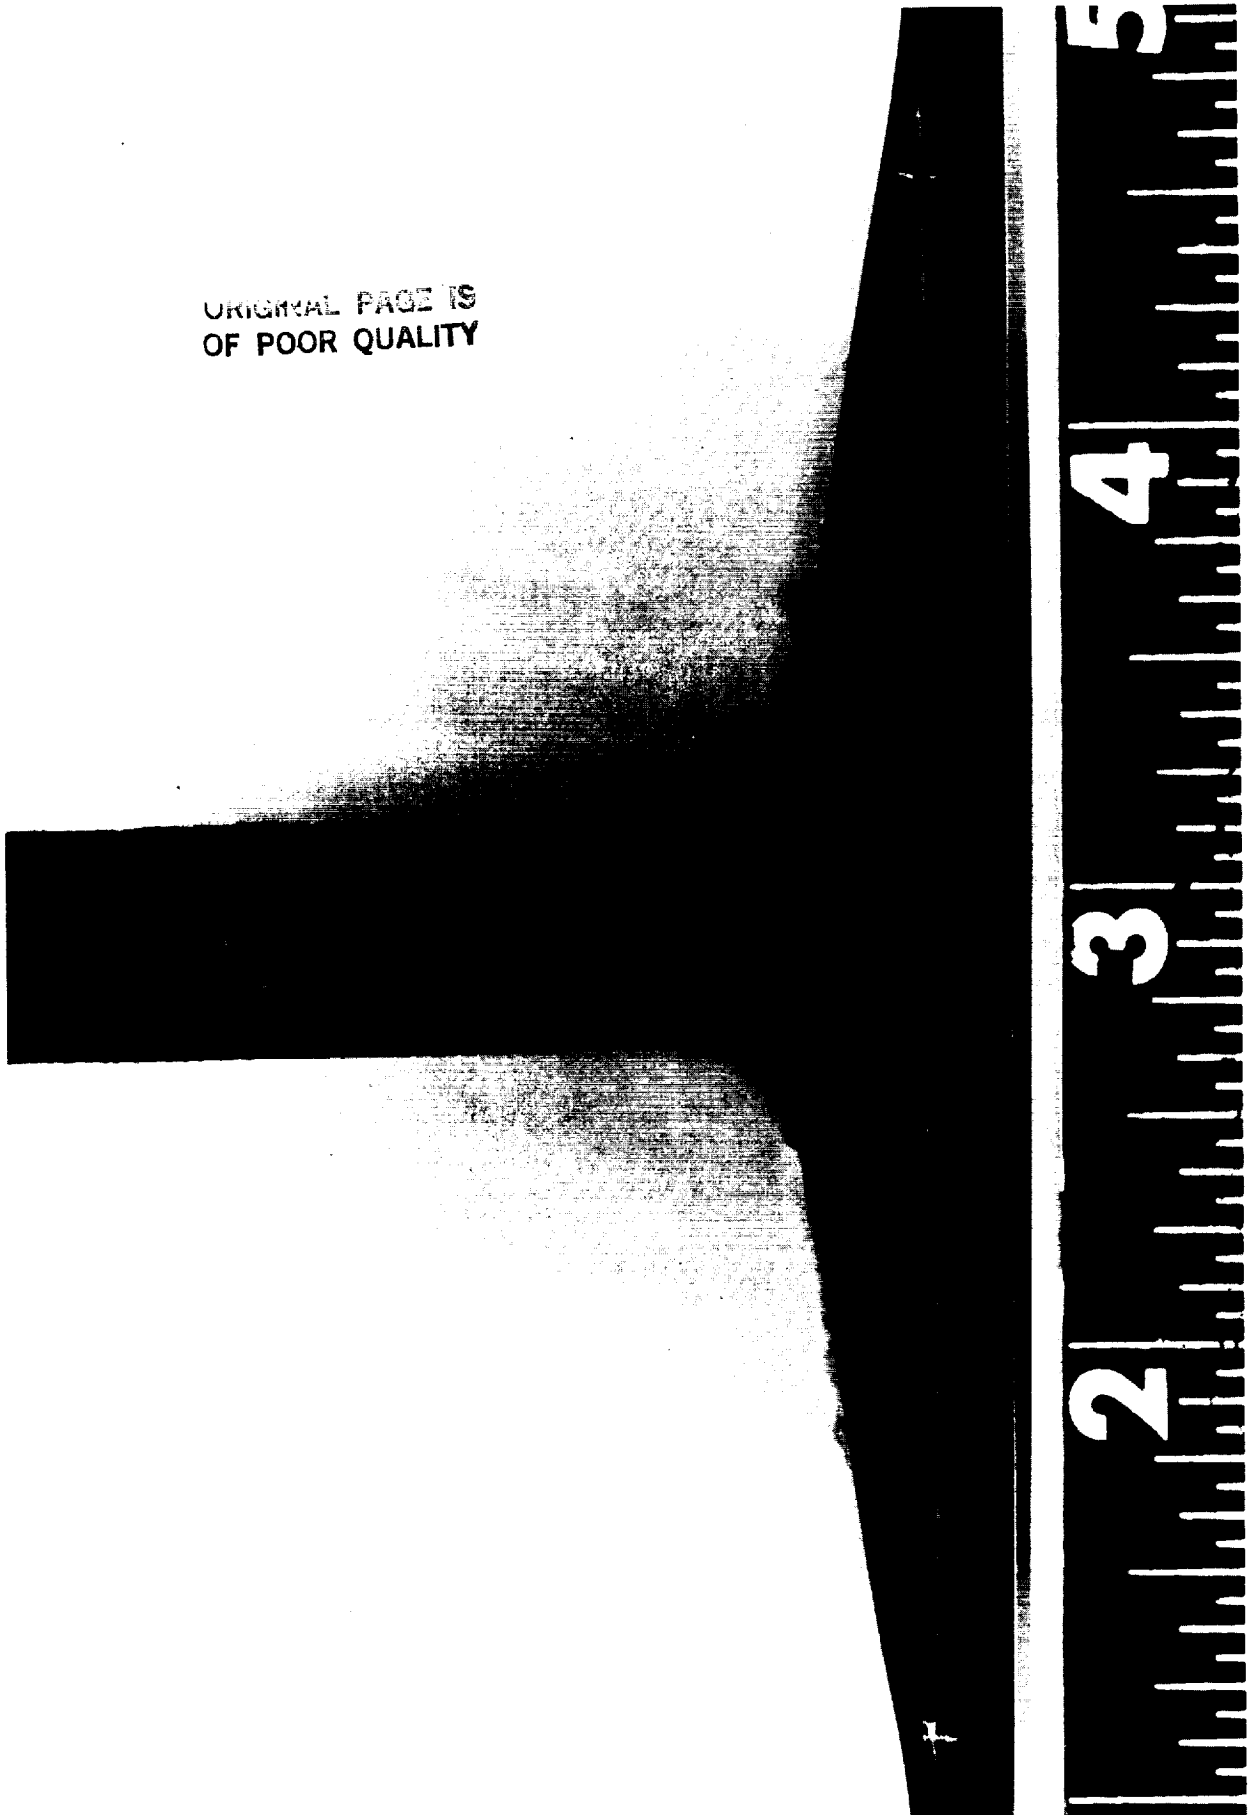
Figure 4-16: Stiffener pull-off specimen C4 failure.

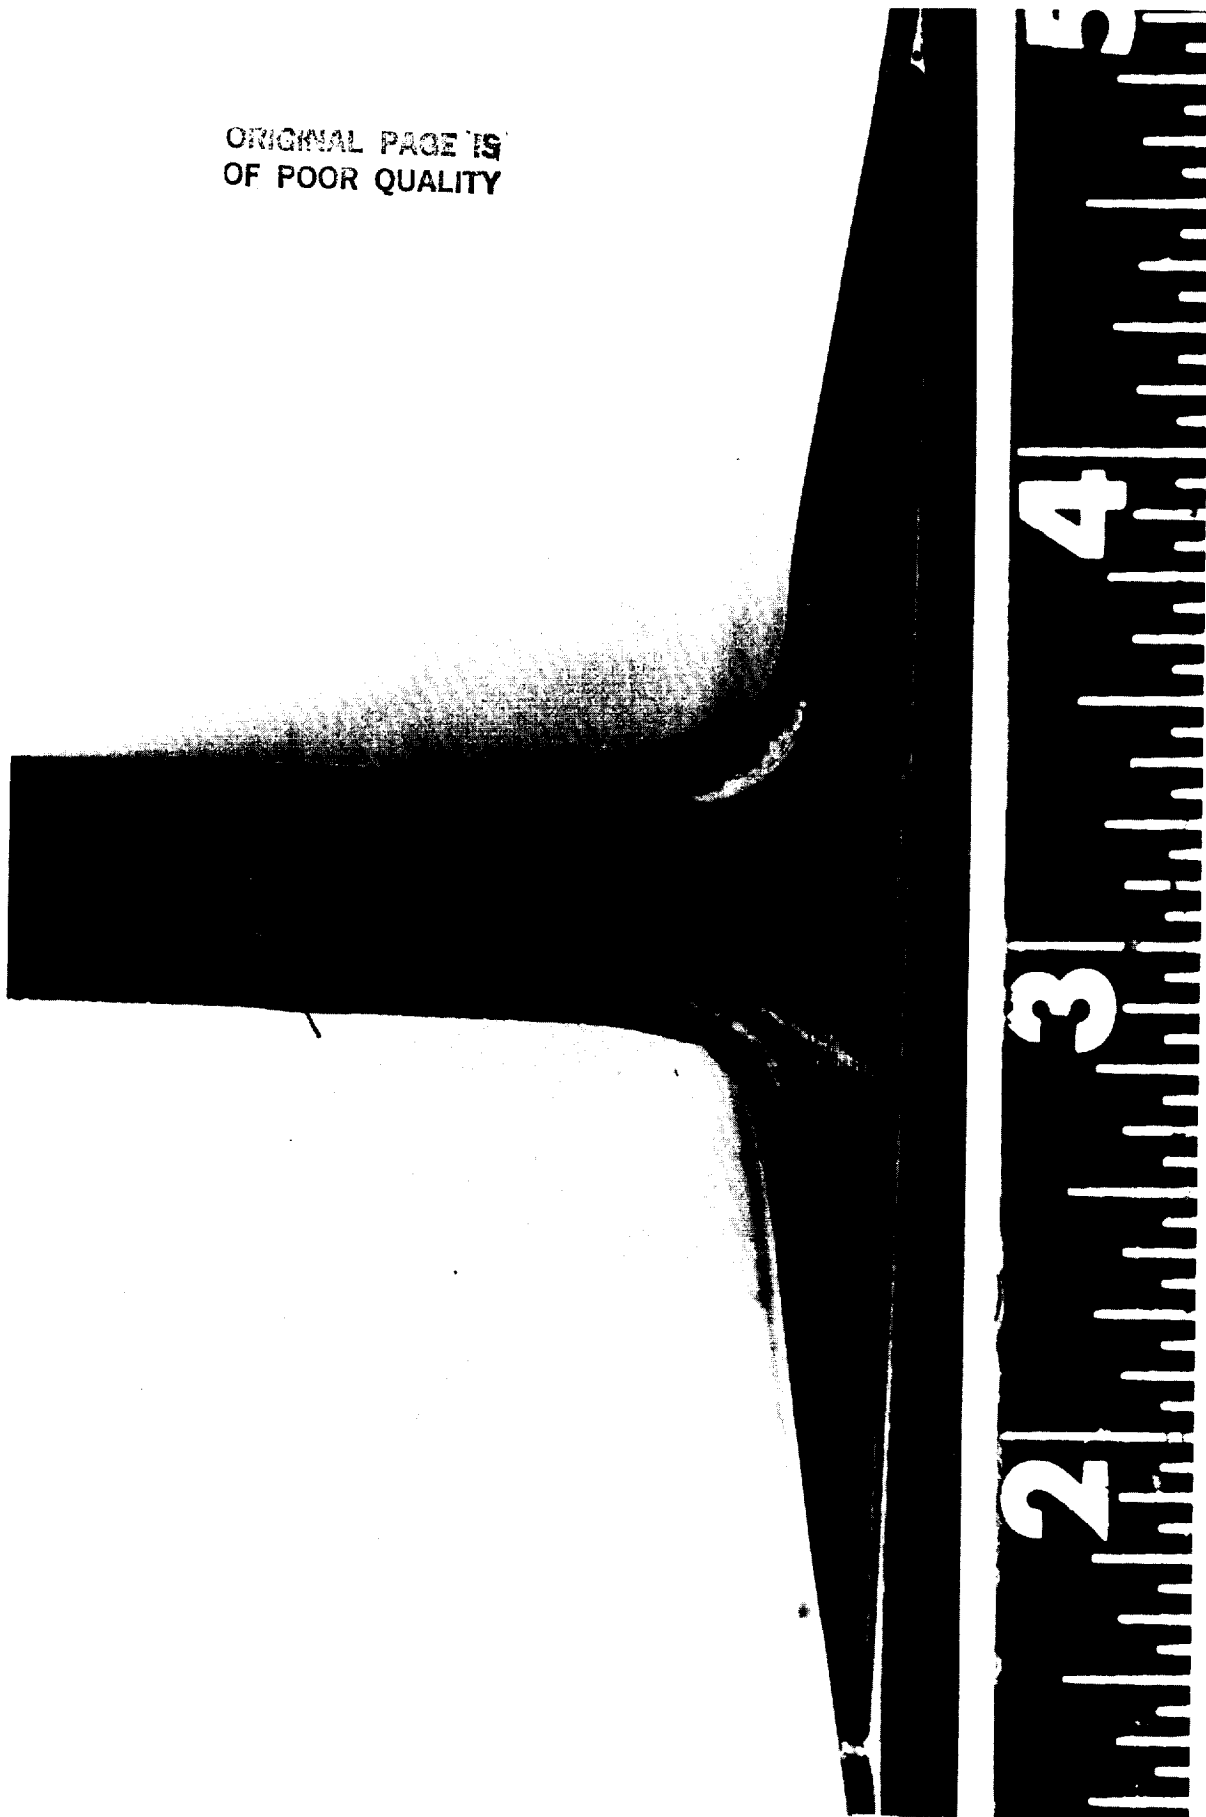
Figure 4-22: Stiffener side load specimen D1 failure.
